The Problem With Twin Cessna Axle & Wheel-End Assembly

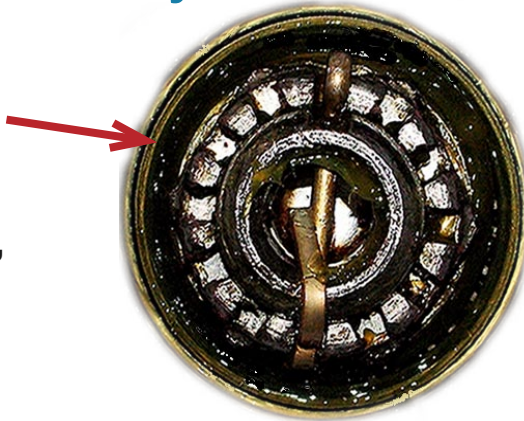
Looks can be deceiving: the axel nut appears to be properly secured with the cotter pin, but, in fact, it probably is not.

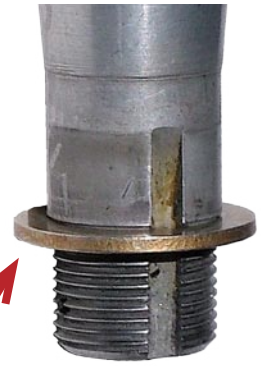
Washer abuts 90 degree cut

Installation of wheel end-components on the tapered axle, just past the threads, is a 90 degree cut that the washer abuts against on the axle. However, It may not abut the bearing, leaving a gap, thereby creating a path to potential bearing and axle damage or failure.

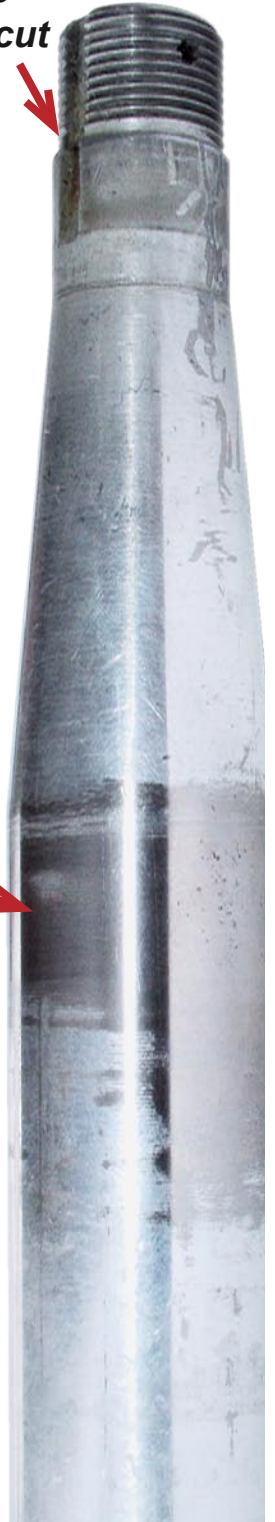
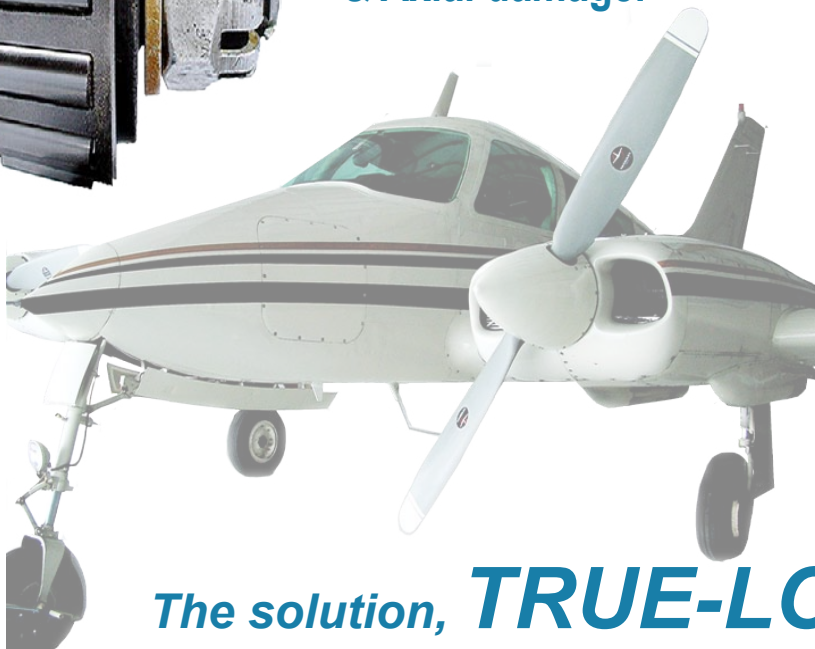
The axle nut fails to abut the bearing allowing for bearing pre-load. Radial & Axial damage.

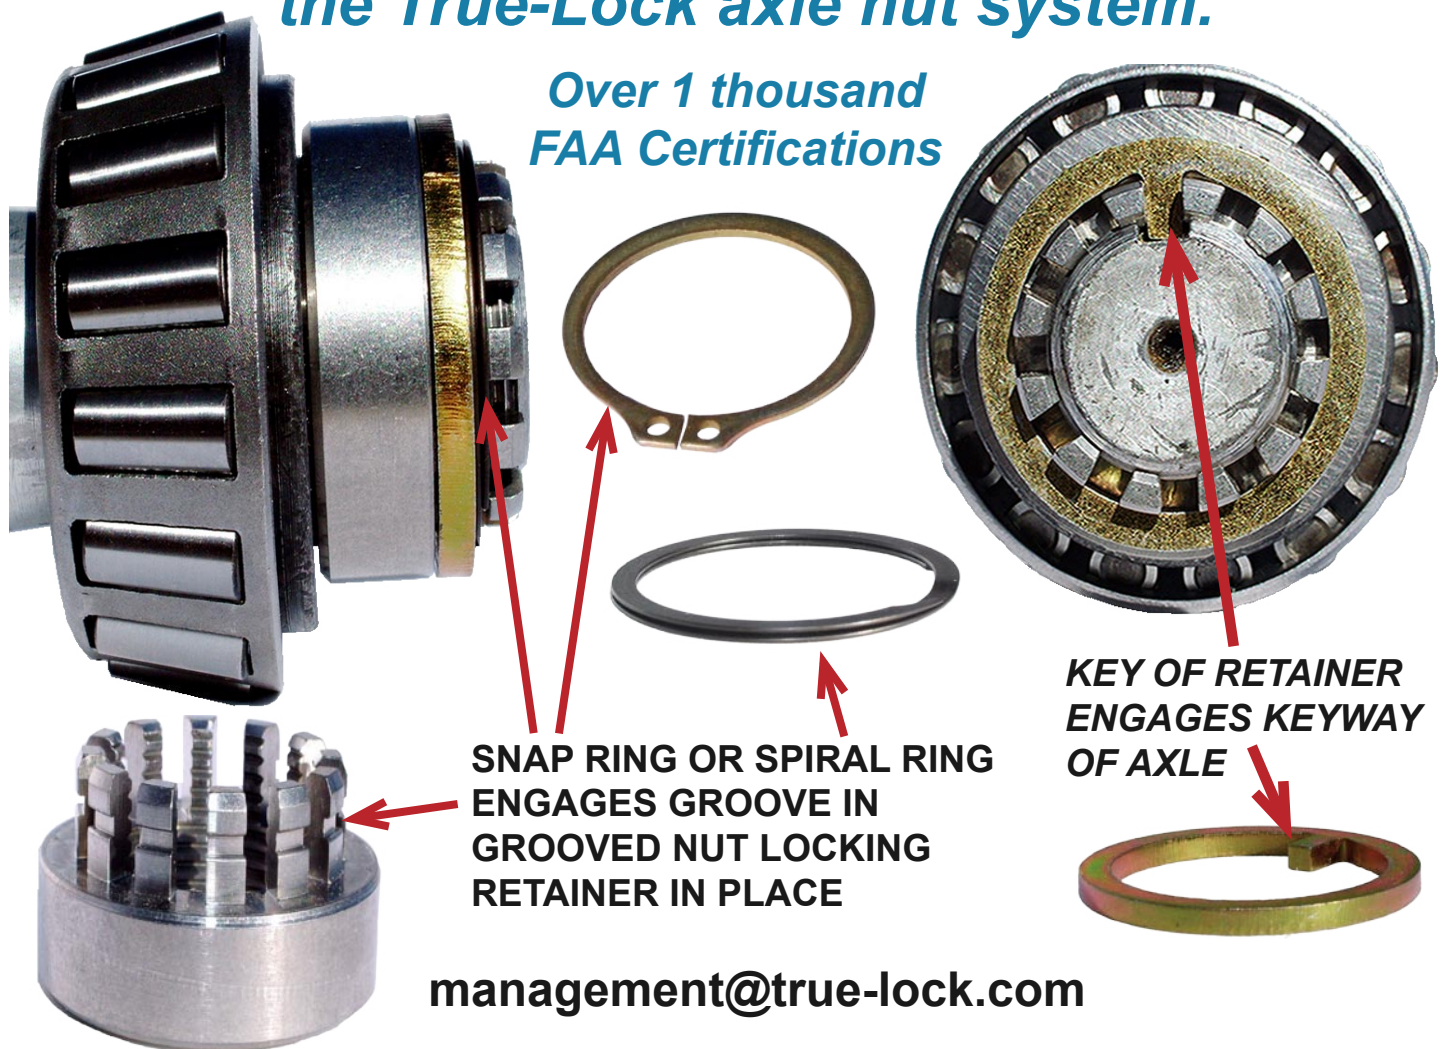
The problem can be solved using the True-Lock axle nut system.
